**Flood Control Project Maintenance
Levee Inspections**
LMA District Cover Sheet
Spring 2019 Levee Inspection Results

Sacramento Maintenance Yard East Levee Yolo Bypass

Spring 2019 Levee Inspection Results

Levee Inspection Report By Mile - Spring 2019

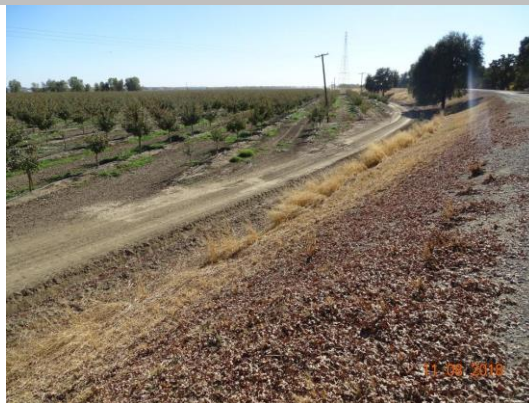
Photo 1 of 1 : SP_2019_ST0004_41_2_20190304_00004.jpg

LM Start	0.01	Rating **	M	Issue No.	2
LM End	0.15	Issue Type +	En	Location *	LS
Category	Earthen Levee			GPS Latitude/Longitude	
				Start	End
Item	Encroachments			38.765181 °	38.763164 °
				-121.635131 °	-121.635438 °
DWR ID	DWR_ST0004_01_f_2018_2				
Comment Code					
DT : Ditch					
Inspector Comment					
Landowner has dug irrigation ditch within landside easement.

View of irrigation ditch near the landside toe. Fall 2018.

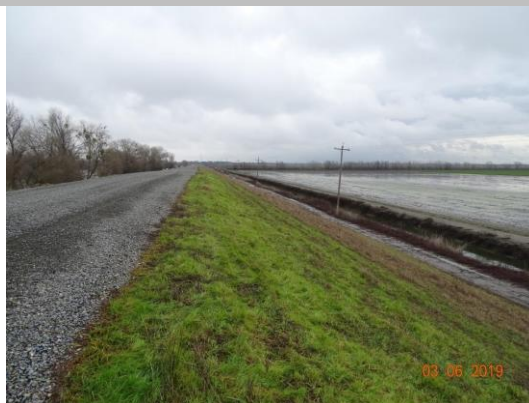
Photo 1 of 1 : SP_2019_ST0004_41_8_20190311_00011.jpg

LM Start	1.51	Rating **	A	Issue No.	8
LM End	1.51	Issue Type +	Ma	Location *	LS
Category	Earthen Levee			GPS Latitude/Longitude	
				Start	End
Item	Vegetation			38.743589 °	38.743589 °
				-121.634173 °	-121.634173 °
DWR ID	DWR_ST0004_01_s_2019_8				
Comment Code					
V1 : Control annual grass and weeds on the levee slopes and easements.					
Inspector Comment					
LMA maintains vegetation at an acceptable level.

View of well-maintained vegetation on the landside slope. Spring 2019.

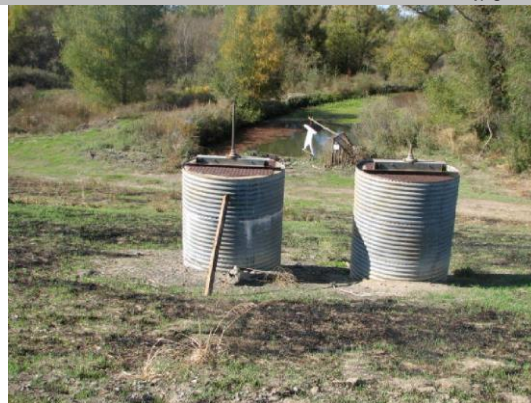
Photo 1 of 3 : UCIP_SP_2019_53253_60261.jpg

Comment Code						
Inspector Comment						
FS_ID:53253 DS_ID:838 EP_NO: N/A Repair Type: No Action Needed Crossing Status: Found UCIP Comments: 11/16/17 Ted Skidgel, pipe is closed on w/s and closed on L/S. Mud removed recently from WS pipes. FIELD_STRUCT_DESC: 1 of 2: 48-inch corrugated metal drainage pipe through the levee, 28.5 feet below the crown. 30-inch steel pipe sleeved through the 48-inch pipe. Slide gate in a 60-inch pipe riser on the waterside (WS) slope. [Additional Reference(s): DWR Levee Log, 1981. USACE Sacramento O&M Manual 123, August 1955, (Station 382+85)]. No permit or as-built drawing available. FS Date: 11/21/2018 8:31:59 AM

Waterside view: overview CMP standpipe and water body

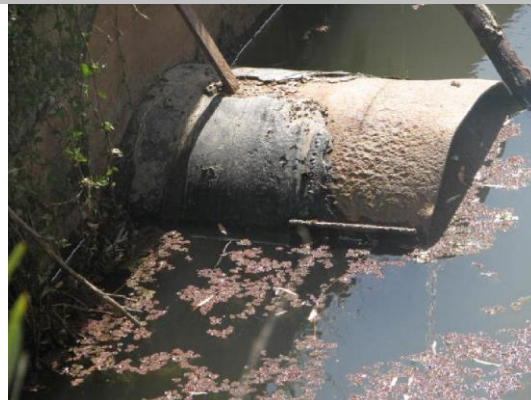
Photo 2 of 3 : UCIP_SP_2019_53253_60260.jpg

Waterside view: steel pipe and concrete headwall

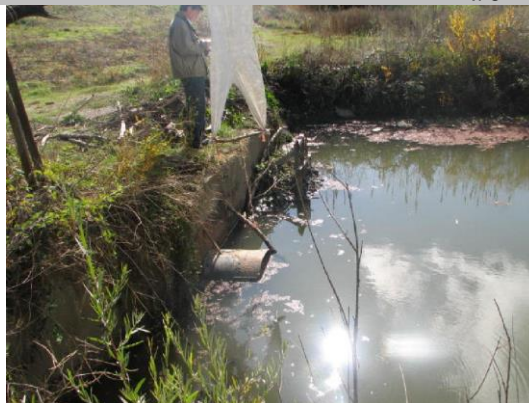
Photo 3 of 3 : UCIP_SP_2019_53253_60259.jpg

Comment Code						
Inspector Comment						
FS_ID:53253 DS_ID:838 EP_NO: N/A Repair Type: No Action Needed Crossing Status: Found UCIP Comments: 11/16/17 Ted Skidgel, pipe is closed on w/s and closed on L/S. Mud removed recently from WS pipes. FIELD_STRUCT_DESC: 1 of 2: 48-inch corrugated metal drainage pipe through the levee, 28.5 feet below the crown. 30-inch steel pipe sleeved through the 48-inch pipe. Slide gate in a 60-inch pipe riser on the waterside (WS) slope. [Additional Reference(s): DWR Levee Log, 1981. USACE Sacramento O&M Manual 123, August 1955, (Station 382+85)]. No permit or as-built drawing available. FS Date: 11/21/2018 8:31:59 AM

Waterside view: overview steel pipes and concrete headwall

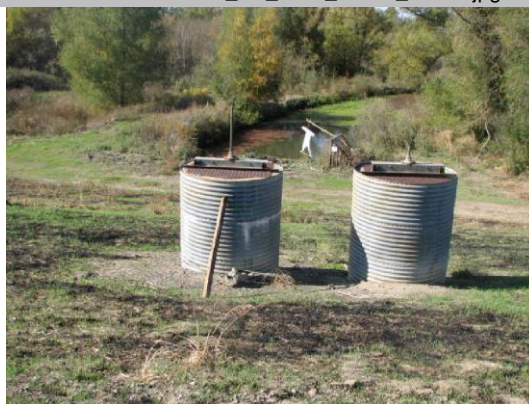
Photo 1 of 3 : UCIP_SP_2019_53254_60269.jpg

LM Start	1.71	Rating **	A/W	Issue No.	10
LM End	1.71	Issue Type +	Ma	Location *	
Category	Supplemental			GPS Latitude/Longitude	
				Start	End
Item	DWR UCIP LMA Responsibility			38.740686 °	38.740686 °
				-121.633979 °	-121.633979 °
DWR ID	840				
Comment Code					
Inspector Comment					
FS_ID:53254 DS_ID:840 EP_NO: N/A Repair Type: No Action Needed Crossing Status: Found UCIP Comments: FIELD_STRUCT_DESC: 2 of 2: 48-inch corrugated metal drainage pipe through the levee, 28.5 feet below the crown. 30-inch steel pipe sleeved through the 48-inch pipe. Slide gate in a 60-inch pipe riser on the waterside (WS) slope. [Additional Reference(s): DWR Levee Log, 1981. USACE Sacramento O&M Manual 123, August 1955, (Station 382+85)]. No permit or as-built drawing available. FS Date: 11/21/2018 8:34:20 AM

Waterside view: overview of CMP standpipe and water body

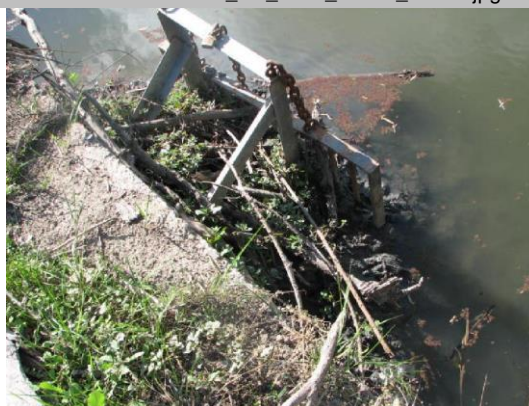
Photo 2 of 3 : UCIP_SP_2019_53254_60268.jpg

LM Start	1.71	Rating **	A/W	Issue No.	10 (cont)	
LM End	1.71	Issue Type +	Ma	Location *		
Category	Supplemental			GPS Latitude/Longitude		
				Start		End
Item	DWR UCIP LMA Responsibility			38.740686 °		38.740686 °
				-121.633979 °		-121.633979 °
DWR ID	840					
Comment Code						
Inspector Comment						
FS_ID:53254 DS_ID:840 EP_NO: N/A Repair Type: No Action Needed Crossing Status: Found UCIP Comments: FIELD_STRUCT_DESC: 2 of 2: 48-inch corrugated metal drainage pipe through the levee, 28.5 feet below the crown. 30-inch steel pipe sleeved through the 48-inch pipe. Slide gate in a 60-inch pipe riser on the waterside (WS) slope. [Additional Reference(s): DWR Levee Log, 1981. USACE Sacramento O&M Manual 123, August 1955, (Station 382+85)]. No permit or as-built drawing available. FS Date: 11/21/2018 8:34:20 AM

Waterside view: mud clogged pipe, trash rack and headwall

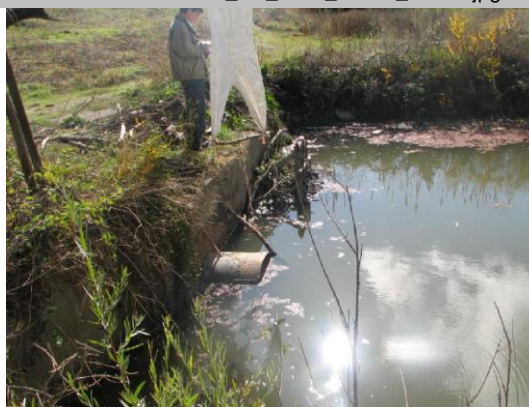
Photo 3 of 3 : UCIP_SP_2019_53254_60267.jpg

Waterside view: overview pipes and headwall
